Re: **City of Santa Rosa Wastewater Treatment Plant (WWTP; SIC 4952; NPDES Compliance Evaluation Inspection; NPDES Permit No. NM0029948; Inspection Date: June 21, 2018**

NPDES Compliance Inspection Report

City of Santa Rosa Wastewater Treatment Plant (WWTP)
NPDES Permit No. NM0024988
Compliance Evaluation Inspection
Date of Inspection: June 21, 2018

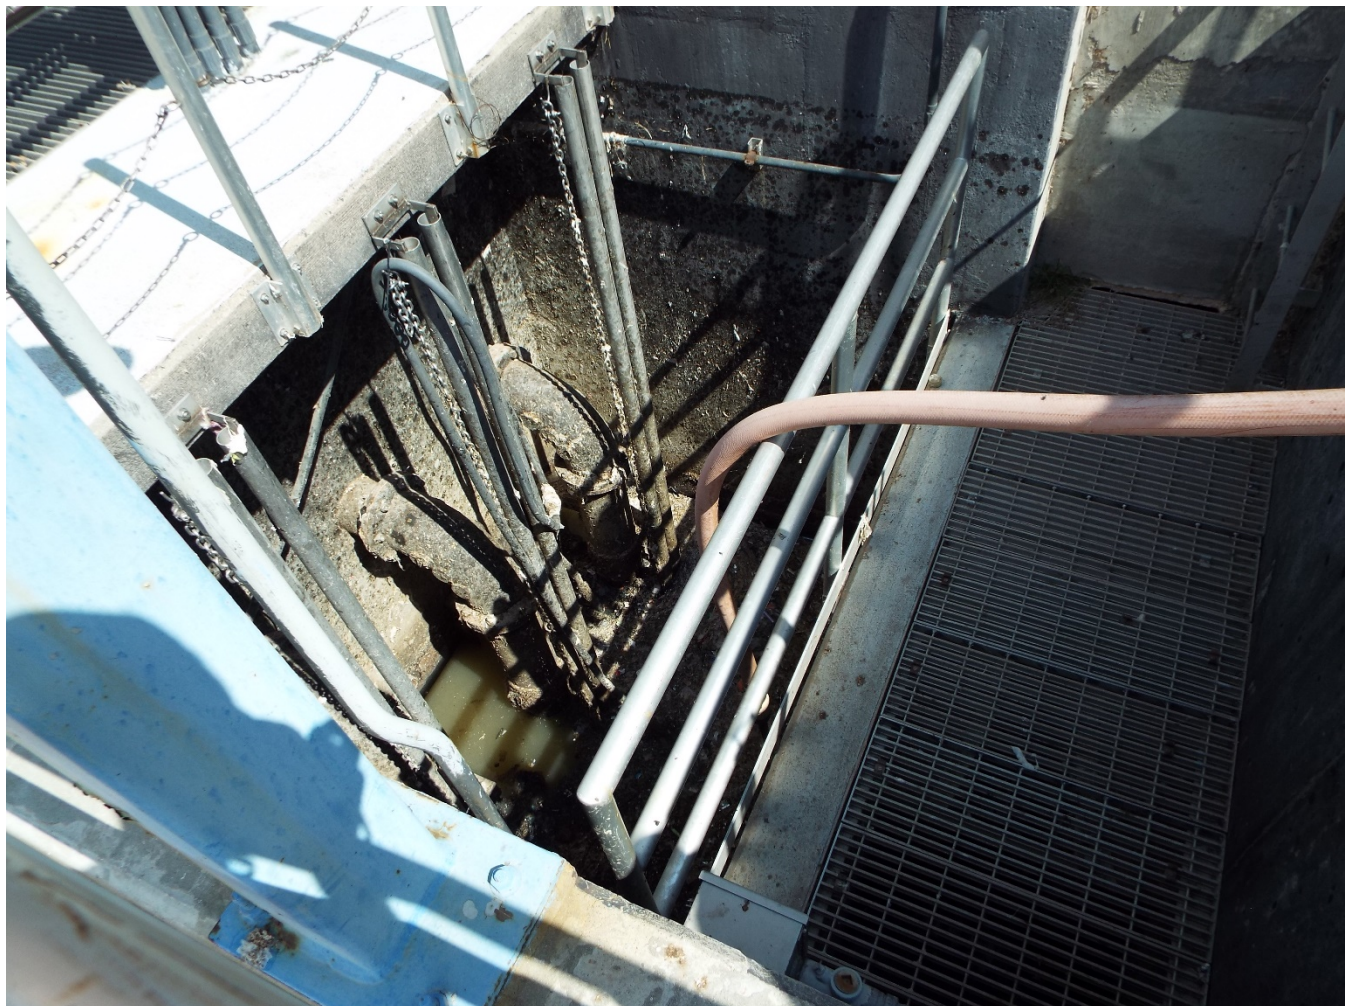
NMED/SWQB
Official Photograph Log
Photo # 1

Photographer: Daniel Valenta	Date: 06/21/2018	Time: 10:19 Hours
City/County: Santa Rosa / Guadalupe		State: New Mexico
Location: Santa Rosa WWTP		
Subject: Influent lift station.

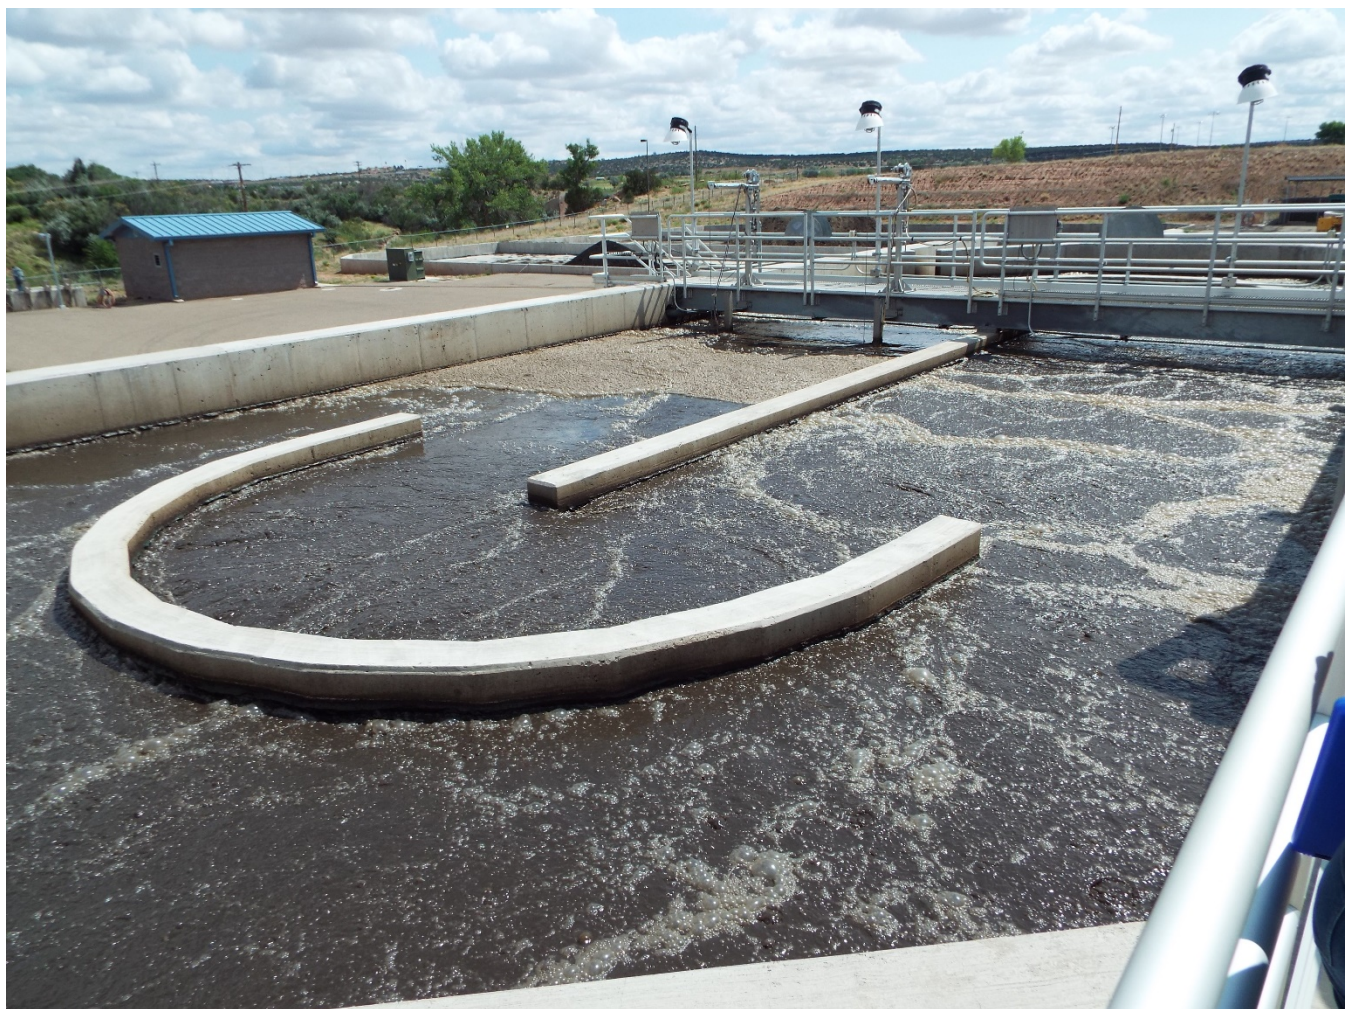
NMED/SWQB
Official Photograph Log
Photo # 2

Photographer: Daniel Valenta	Date: 06/21/2018	Time: 10:36 Hours
City/County: Santa Rosa / Guadalupe		State: New Mexico
Location: Santa Rosa WWTP		
Subject: Oxidation Ditch (one of two)

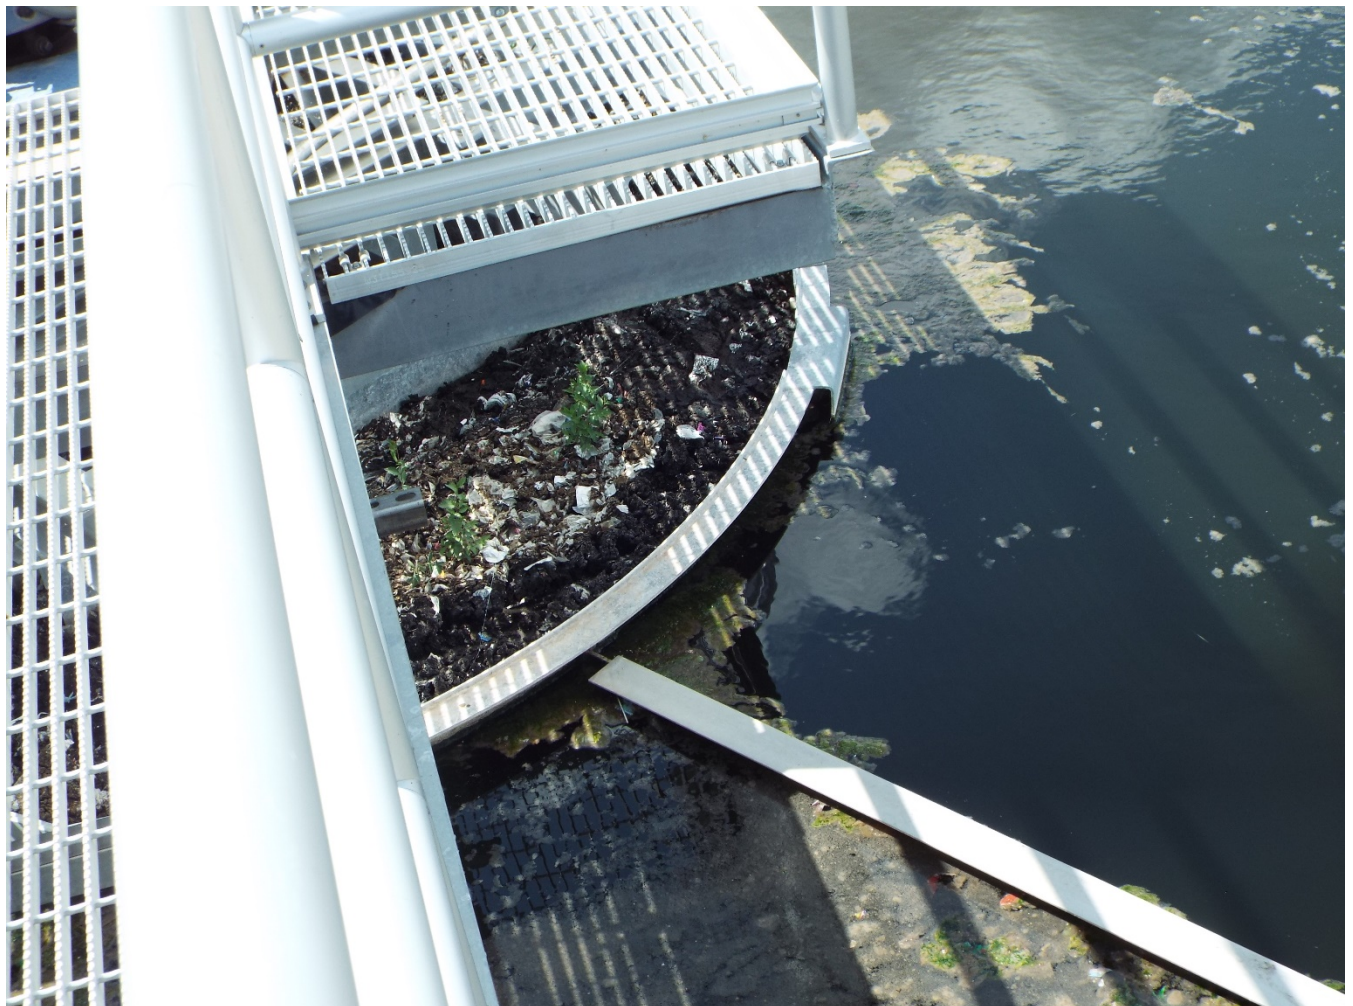
NMED/SWQB
Official Photograph Log
Photo # 3

Photographer: Daniel Valenta	Date: 06/21/2018	Time: 10:52 Hours
City/County: Santa Rosa / Guadalupe		State: New Mexico
Location: Santa Rosa WWTP		
Subject: Clarifier (one of two) – Notice the trees growing inside the inner ring; indication of overloaded clarifier with solids

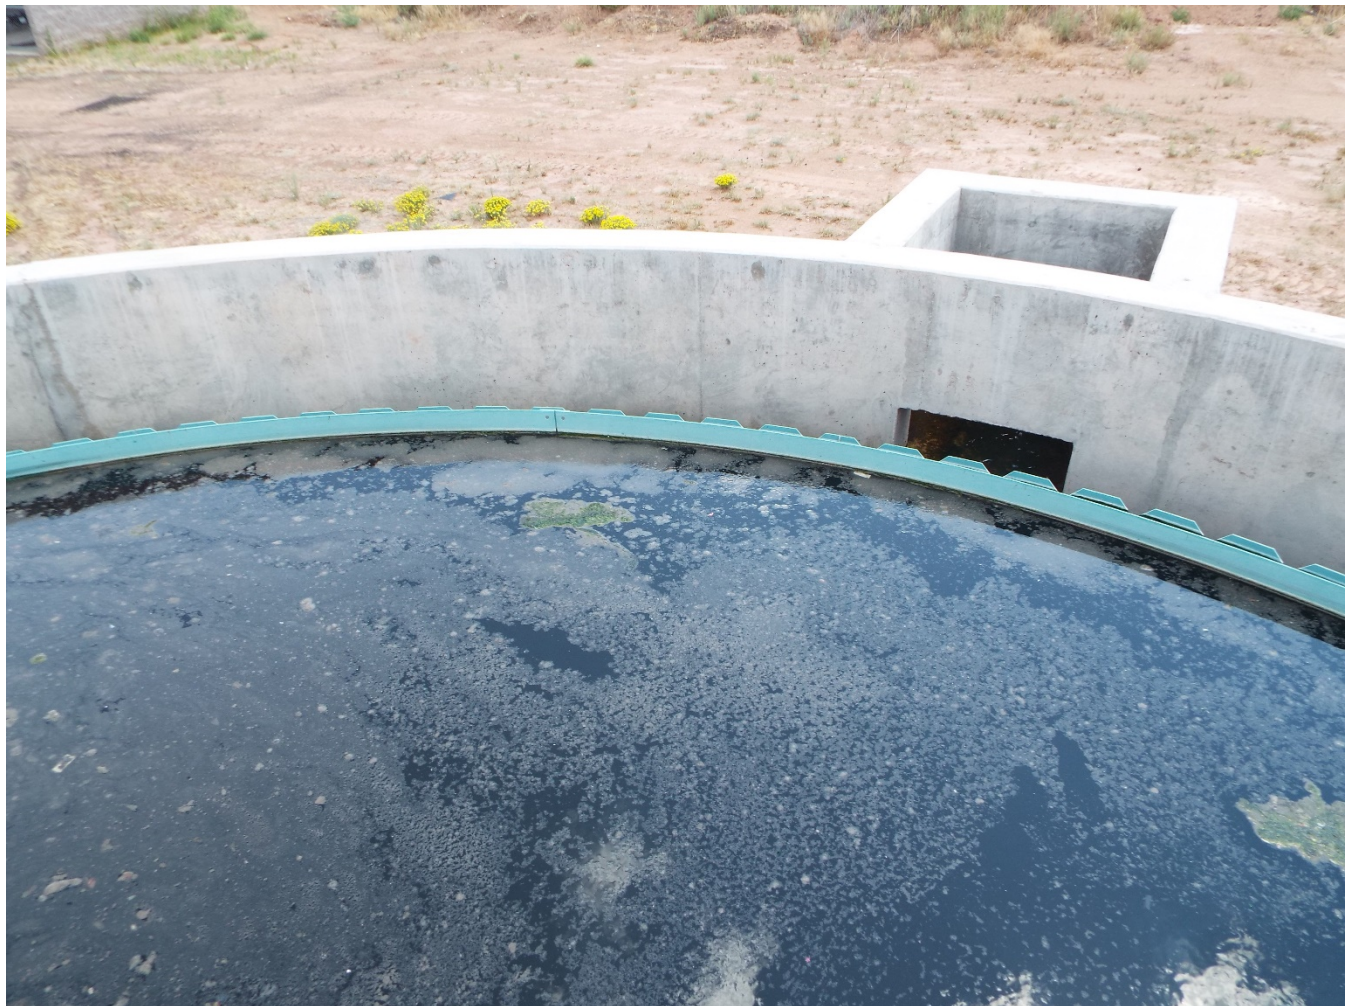
NMED/SWQB
Official Photograph Log
Photo # 4

Photographer: Daniel Valenta	Date: 06/21/2018	Time: 10:53 Hours
City/County: Santa Rosa / Guadalupe		State: New Mexico
Location: Santa Rosa WWTP		
Subject: Another view of the Clarifier (one of two) – Rising sludge; algae

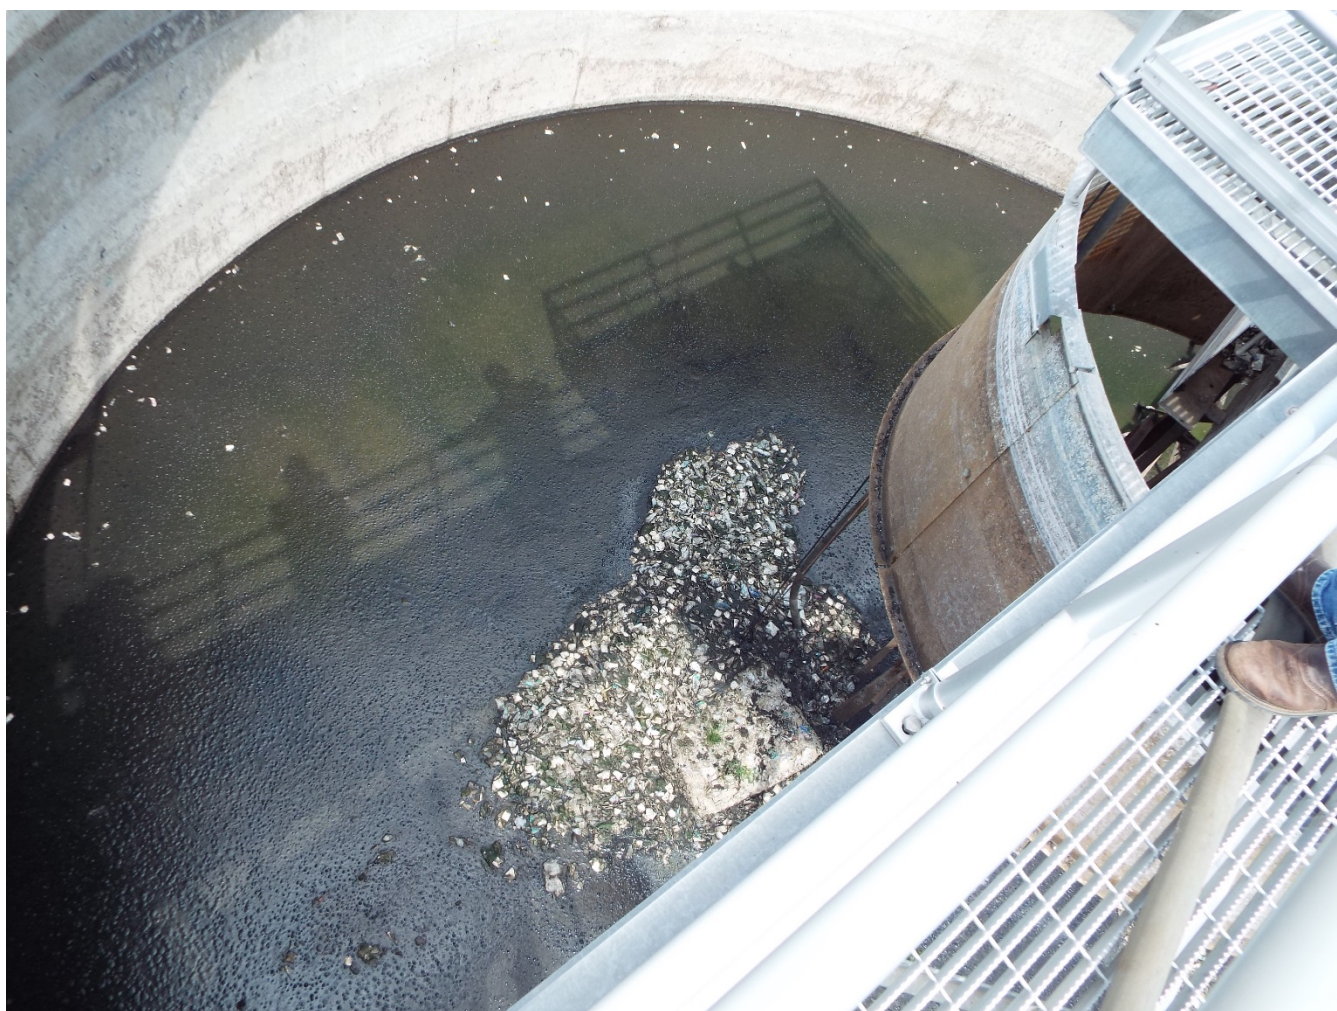
NMED/SWQB
Official Photograph Log
Photo # 5

The facility has a problem occurring at the headworks. The debris and trash passing through the headworks is flowing through the entire plant and discharging to the El Rito Creek. The permittee stated that the contractor had to retrofit the headworks and this may have led to the issue occurring now. It is imperative for this facility to determine the cause and solution to avoid any further discharges.

Photographer: Daniel Valenta	Date: 06/21/2018	Time: 10:55 Hours
City/County: Santa Rosa / Guadalupe		State: New Mexico
Location: Santa Rosa WWTP		
Subject: Empty Clarifier, which is not in use at this time – with debris and trash which is not being removed by the grit/barscreen headworks and is traveling to the clarifier(s).

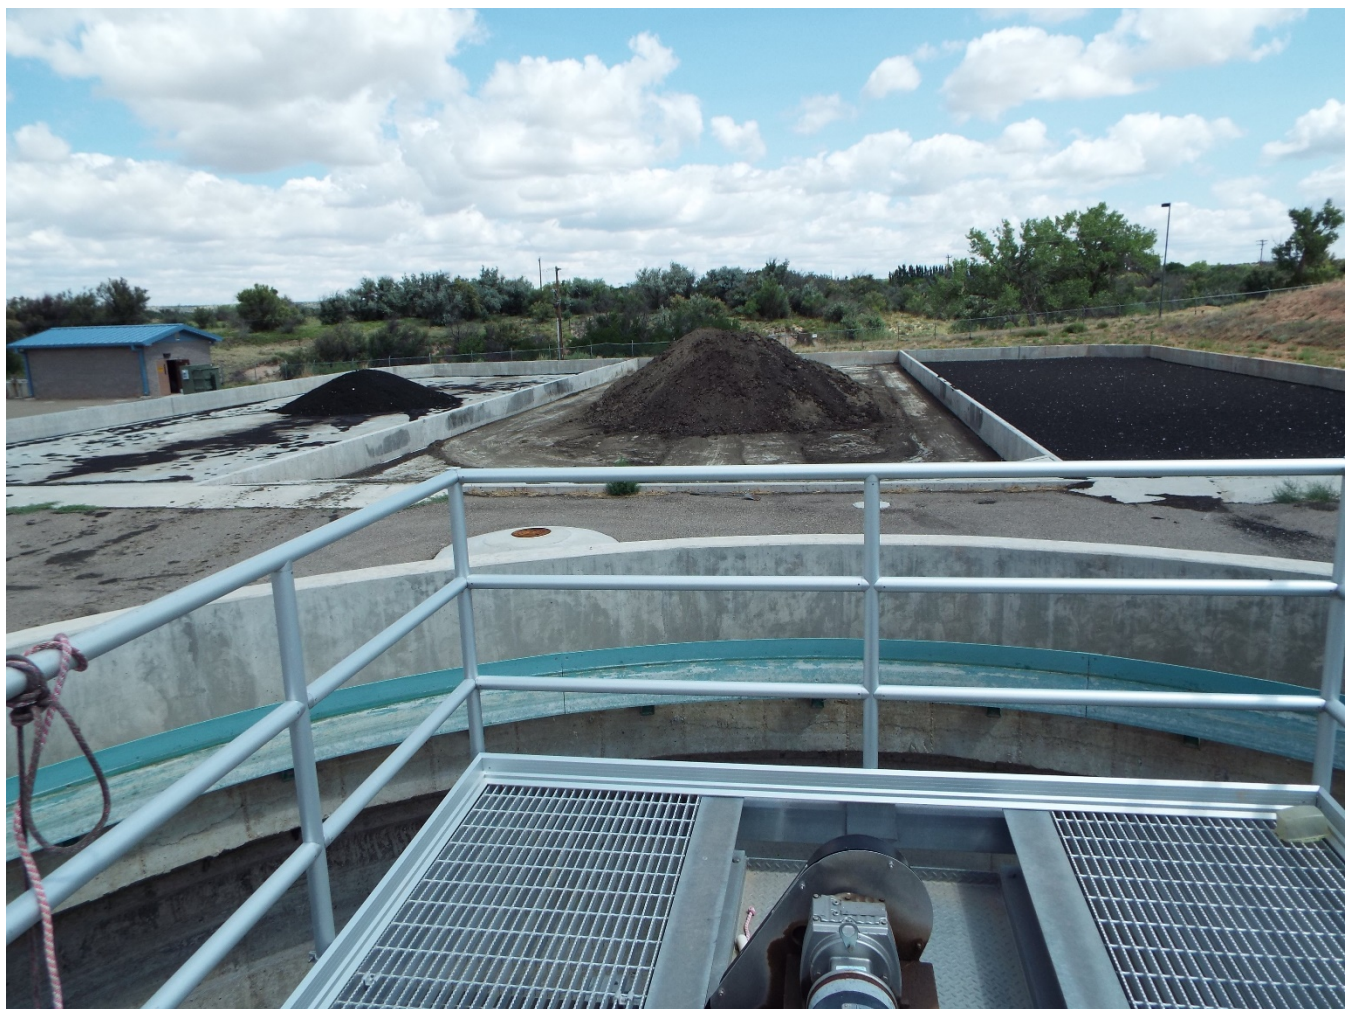
NMED/SWQB
Official Photograph Log
Photo # 6

This facility has failed to follow general requirements, management practices, and operational standards for their sludge disposal. The operator stated that sludge has not been removed for approximately three years. This has exceeded the time allotted in 40 CFR 503.1(y) and must be properly disposed. The operator has had the sludge analyzed, but final disposal has not occurred. The operator stated he is working on getting the sludge removed and placed at special waste landfill.

Photographer: Daniel Valenta	Date: 06/21/2018	Time: 10:56 Hours
City/County: Santa Rosa / Guadalupe		State: New Mexico
Location: Santa Rosa WWTP		
Subject: Sludge drying beds; middle sludge drying bed has been stored on site for 3+ years.

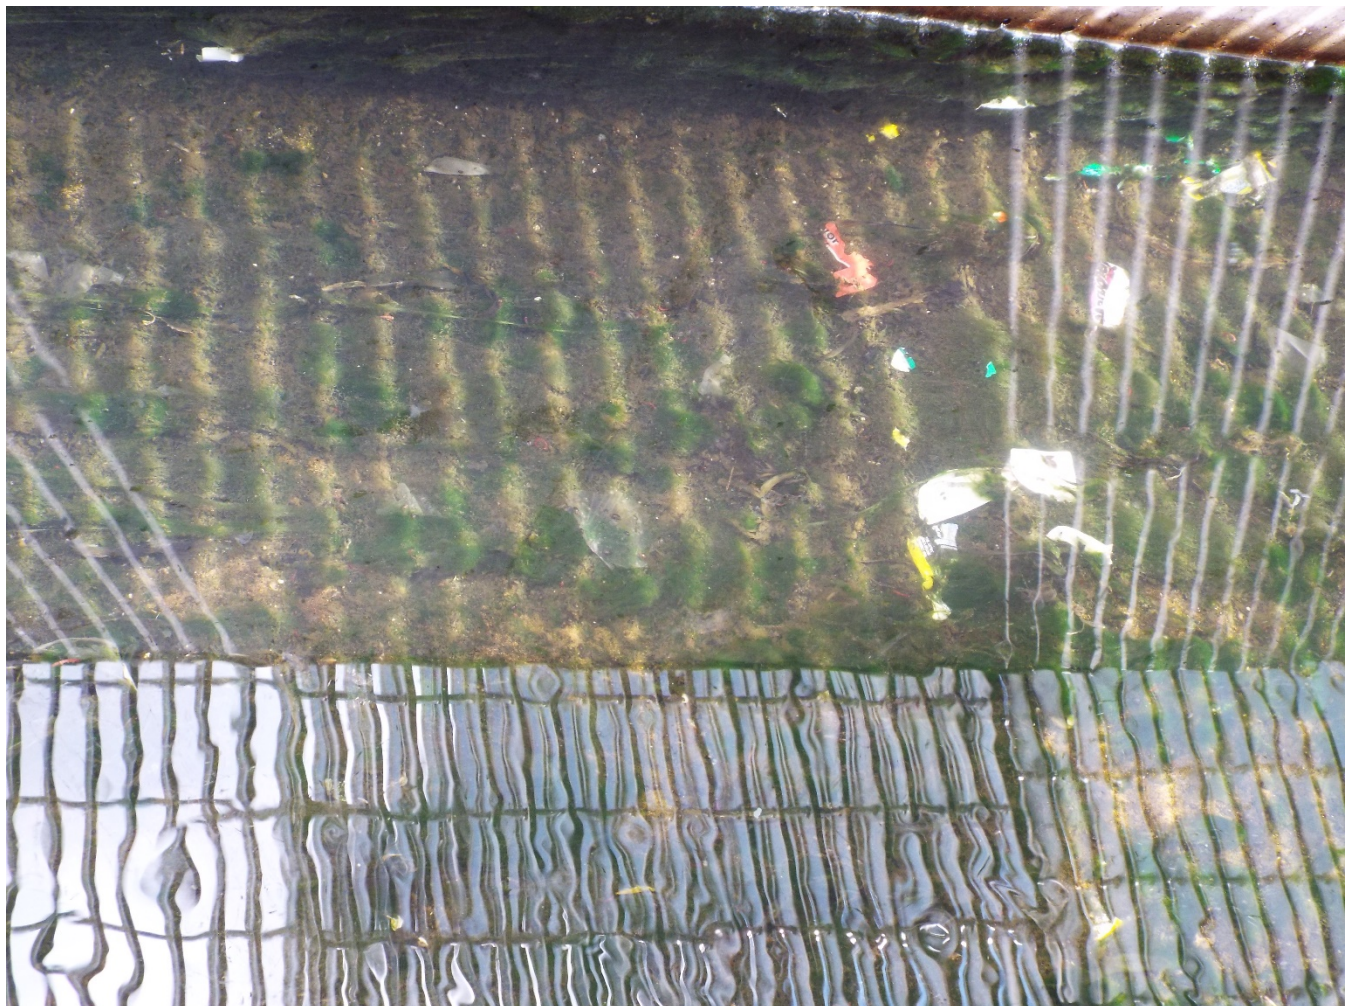
NMED/SWQB
Official Photograph Log
Photo # 7

Photographer: Daniel Valenta	Date: 06/21/2018	Time: 11:10 Hours
City/County: Santa Rosa / Guadalupe		State: New Mexico
Location: Santa Rosa WWTP		
Subject: Effluent Channel – debris/trash and algae exiting the facility and entering the El Rito Creek.

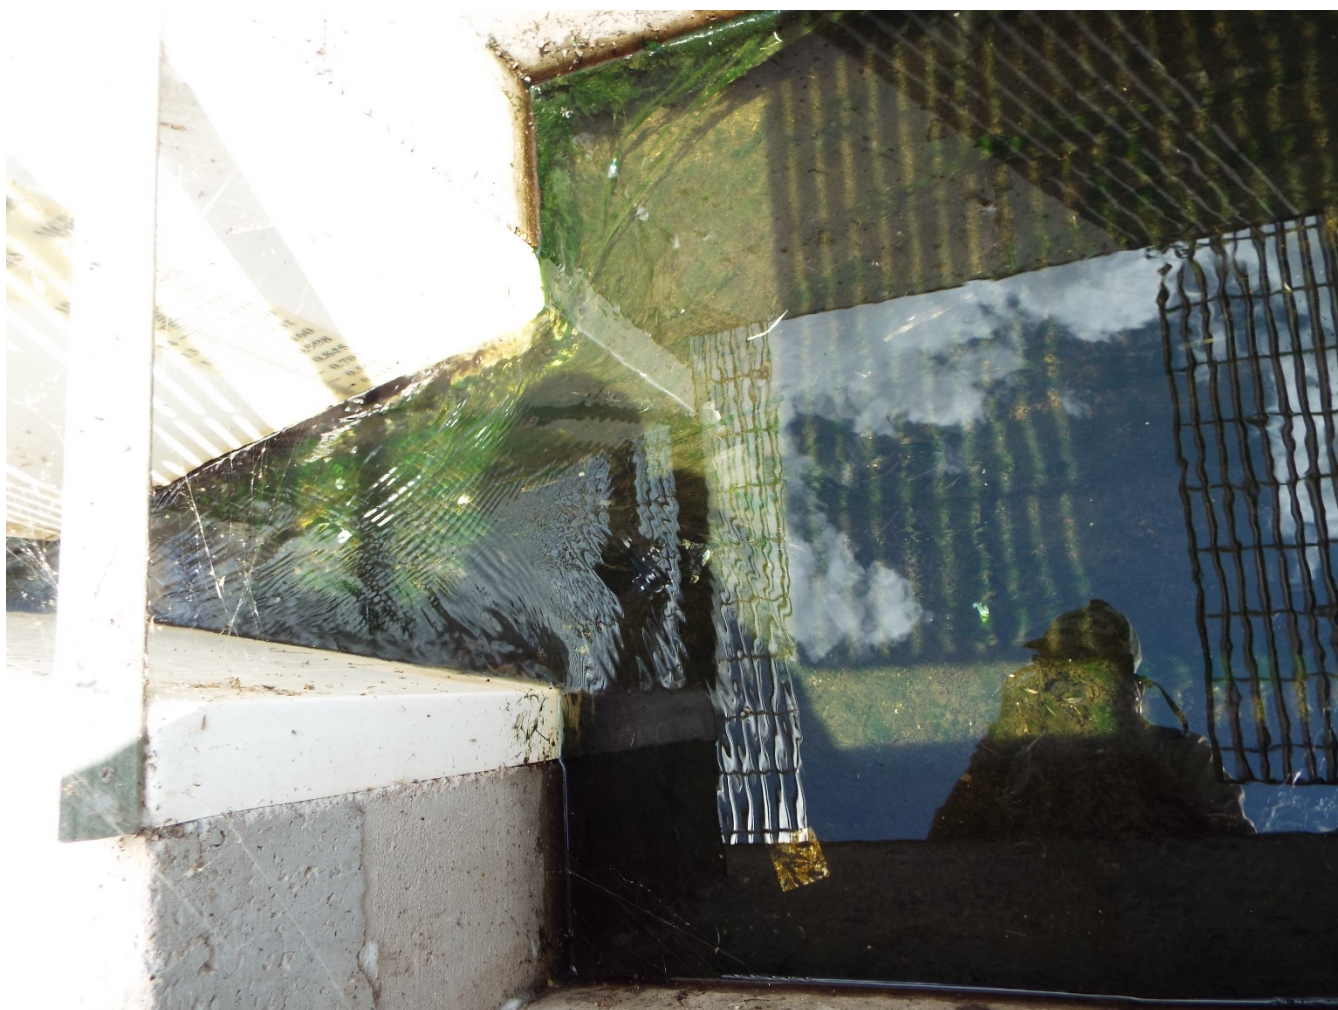
NMED/SWQB
Official Photograph Log
Photo # 8

The permittee does not do calibration checks between the primary and secondary devices during the interim of a scheduled calibration from an outside representative (annually). Calibration checks insure that the totalizer has not changed in the accuracy of reliability. Flow measurements are an important part of mass load calculations.

Photographer: Daniel Valenta	Date: 06/21/2018	Time: 11:12 Hours
City/County: Santa Rosa / Guadalupe		State: New Mexico
Location: Santa Rosa WWTP		
Subject: Parshall flume in the Effluent Channel – debris/trash and algae exiting the facility and entering the El Rito Creek.

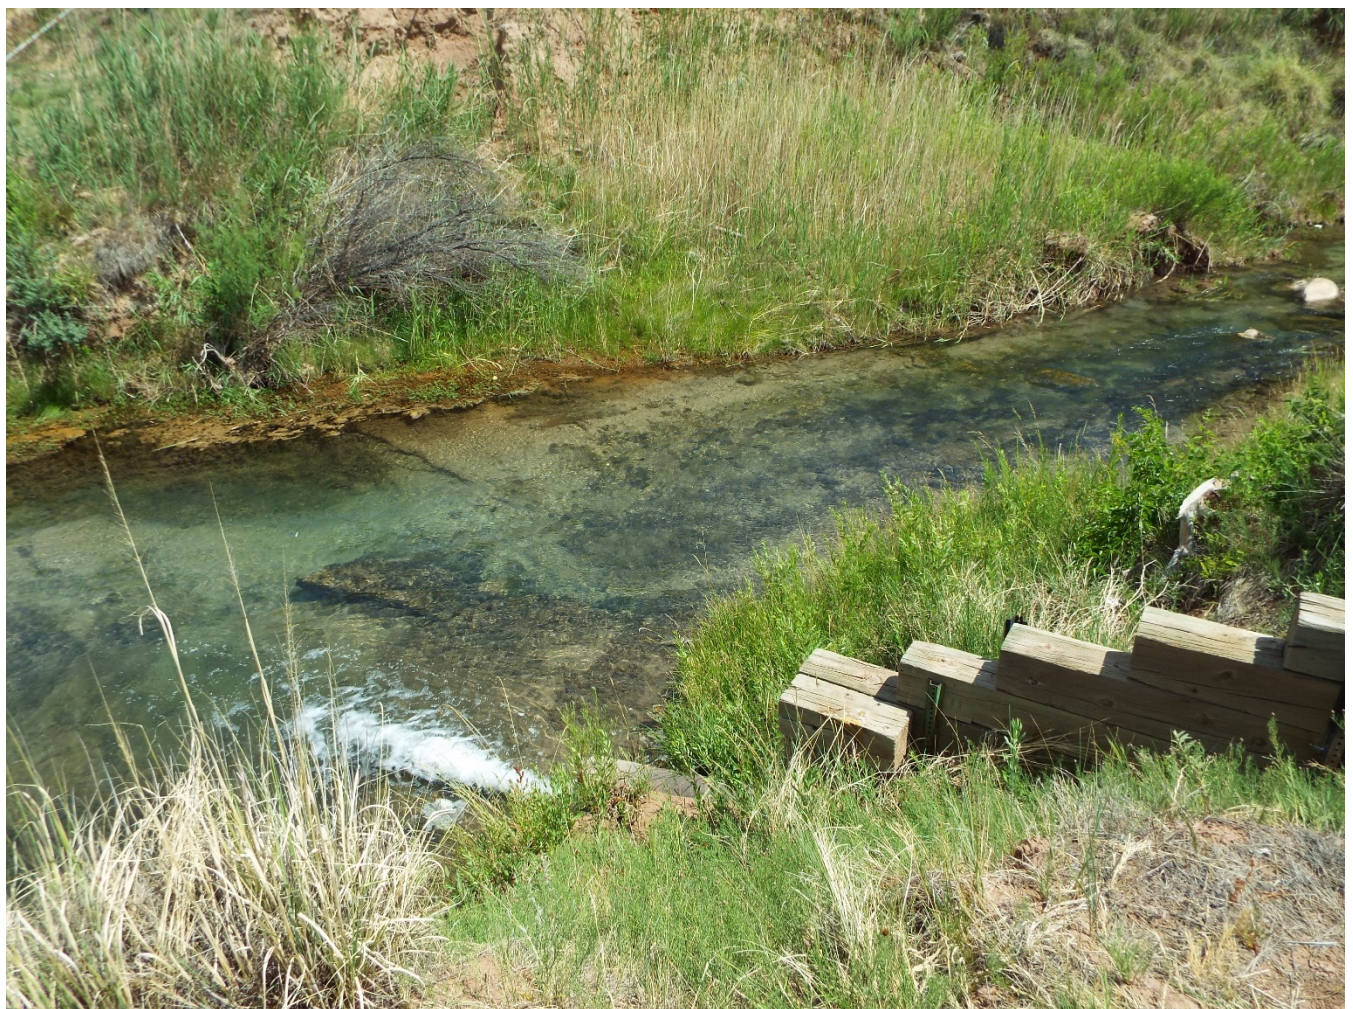
NMED/SWQB
Official Photograph Log
Photo # 9

RECEIVING WATER OBSERVATIONS: Visible debris along with some foaming was seen at the outfall into the El Rito Creek.							
SECTION H - SLUDGE DISPOSAL							
SLUDGE DISPOSAL MEETS PERMIT REQUIREMENTS. DETAILS:				<input type="checkbox"/> S <input type="checkbox"/> M <input checked="" type="checkbox"/> U <input type="checkbox"/> NA (FURTHER EXPLANATION ATTACHED <u>YES</u>).

Photographer: Daniel Valenta	Date: 06/21/2018	Time: 11:21 Hours
City/County: Santa Rosa / Guadalupe		State: New Mexico
Location: Santa Rosa WWTP		
Subject: Effluent entering the El Rito Creek; Foam seen at outfall.
